# Manhole Inspection Summary

Manhole # S21AA\_045MH

Insp Date: **10/26/07 10:31 AM**

**Location** Address: **802 APPLETON-MONROE**

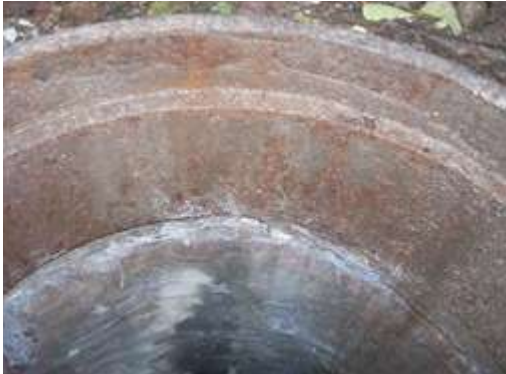
Defect 2

Infiltration: ☐ None ☐ Joint ☐ Cracks ☐ Mortar ☐ Roots ☒ **Wall**

CHIMNEY INFILTRATION

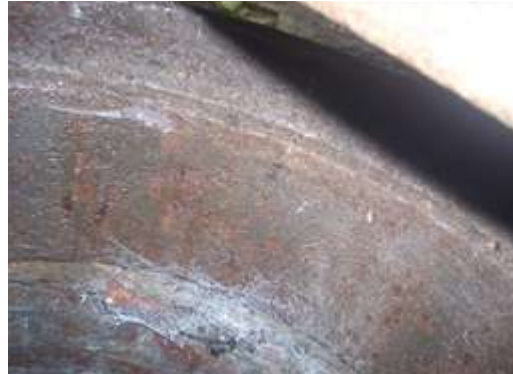
Defect 1

Condition: ☐ Sound ☐ Cracked ☐ Root Intrusion ☐ Loose Brick ☒ **Deteriorated**

DETERIORATED CHMNEY

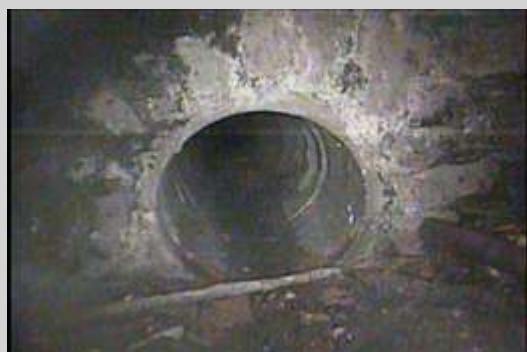
12 O'Clock Outflow

8 in. Circular Gravity Sewer  
Pipe Out @ 12 O'Clock

Infiltration: **None** Pipe Seal Cond: **Sound**
